Manhole Inspection Summary

Manhole # S25EE1022MH

Insp Date: **1/24/07 10:56 AM**

Location Address: **1214 COX ST**

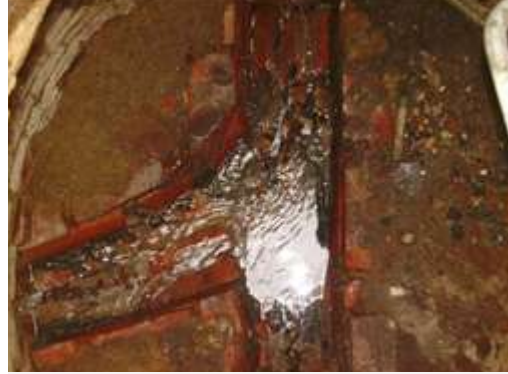
Top View

Evidence of surcharge - Bench debris.
Channel debris.

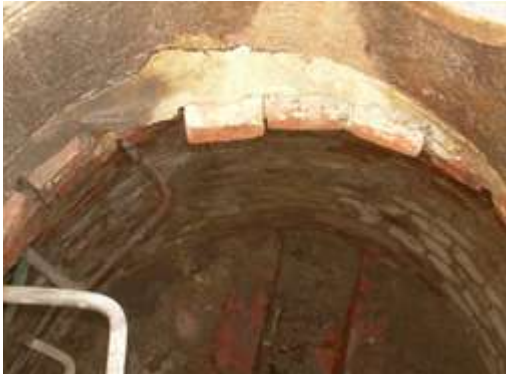
Defect

Frame leaks. Adjustment deterioration,
loose brick and infiltration. Corbel and
Barrel infiltration. Corroded steps.

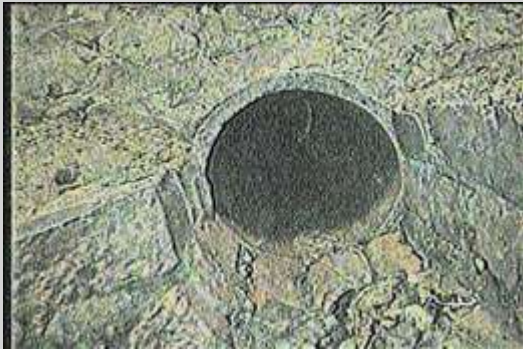
8 in. Circular Gravity Sewer Pipe Out @ 12 O'Clock

Deposits: ☐ None ☐ Mud ☐ Sludge ☒ **Debris** ☒ **Grease**

Infiltration: **Evidence** Pipe Seal Cond: **Unknown**

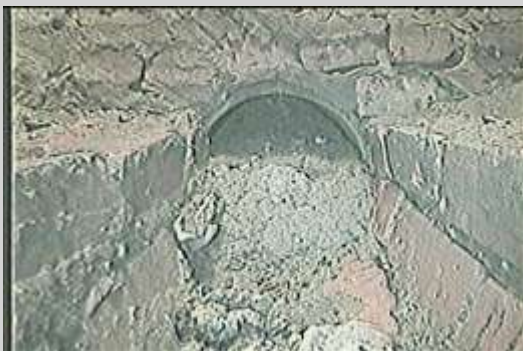
Pipe In @ 6 O'Clock

Barrel deterioration and infiltration. Channel deterioration.

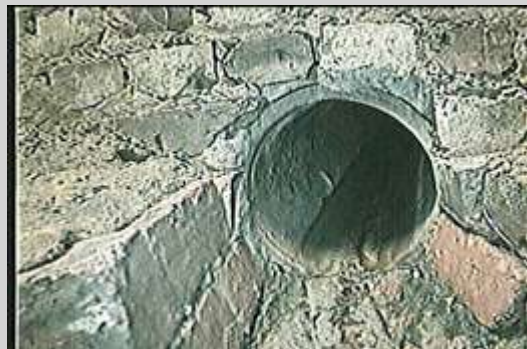
Pipe In @ 8 O'Clock

Barrel deterioration and infiltration. Channel deterioration.
